FOOD PRODUCER

HT-VESSEL IN 1.4404 FAILED
DUE TO HEAVY PITTING
CORROSION – FULL
SUBSTITUTION ON-SITE

Consulting for over 2 years resulted in a reliable Solution & Materials order for this revamping Project

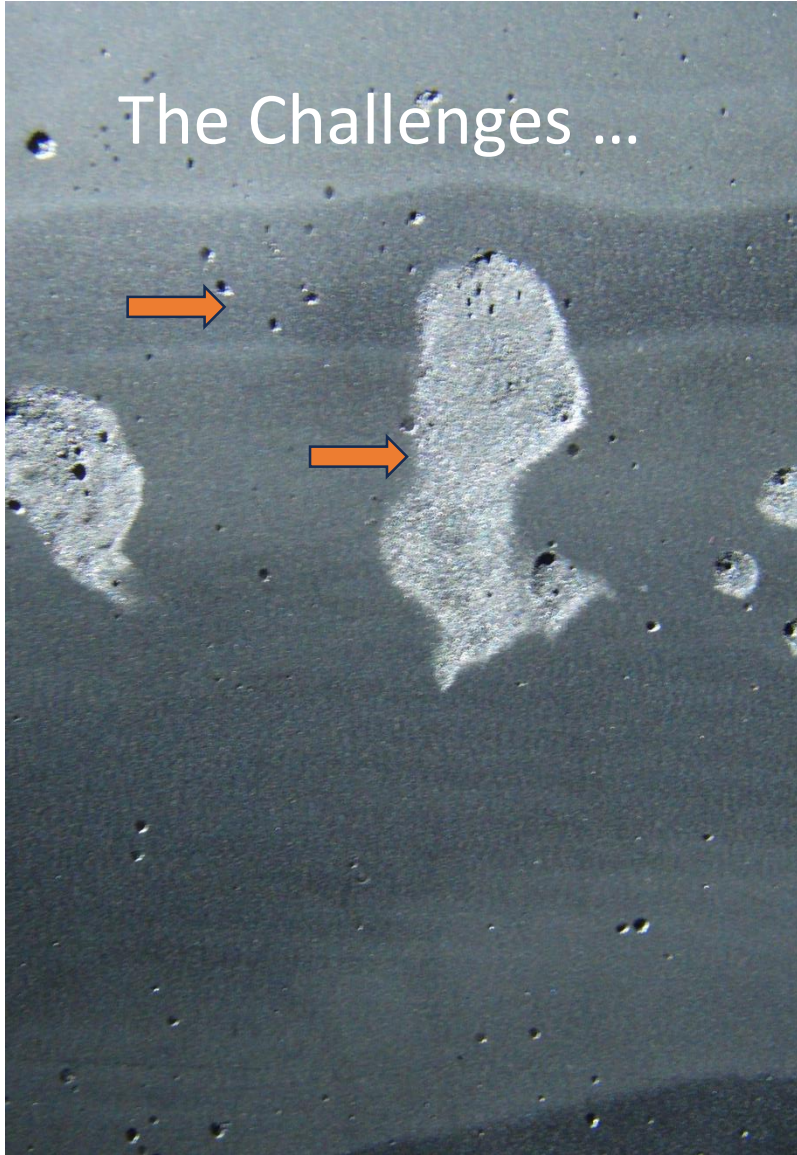
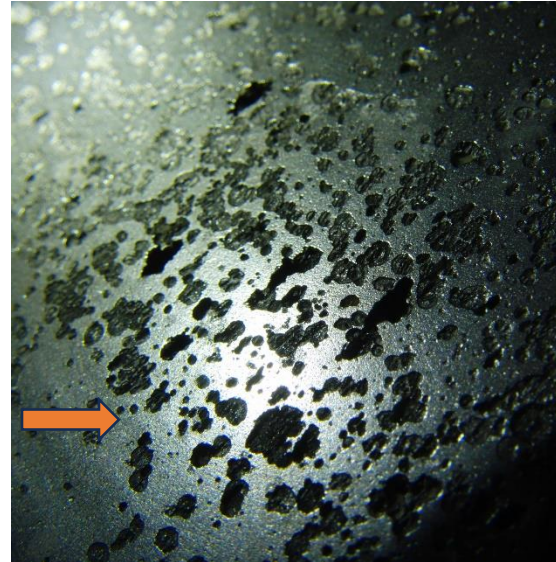
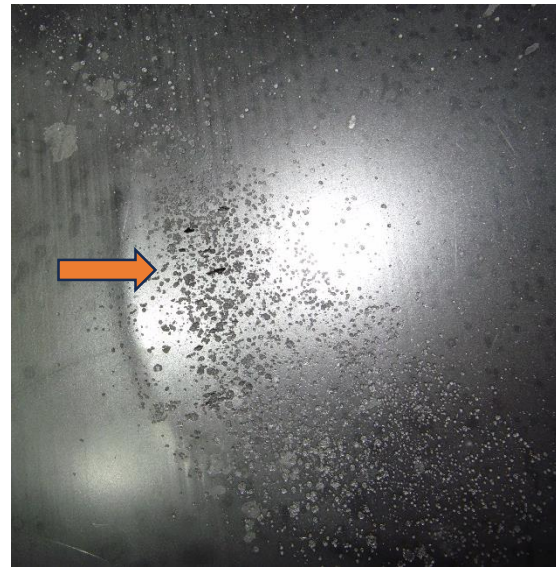
HT VESSEL 316L (1.4404) Inside Surfaces, including Mixer are affected by Pitting Corrosion

- Cooking Vessel for Food Mixtures Processing
H= 7m D=2.5m s=5mm Wall // Vol =24m³
- Temperature Regimes T = 85°C – 145°C /
pH -Regimes 5 down to 3.5 !
- 1st Vessel in Steel Enamel Coating and Mixer in
rubber-lined Construction (2010-2015)
- 2nd Vessel in 316L (1.4404) operated
from 2016-2020
- Heavy Pitting & Crevice Corrosion after
3 years operation only
- Dished Boiler Head close to leakage (!)
- Problem 1 = Vessel Stability / potential Interruption
of Production
- Problem 2 = Food contamination (!)
- Problem 3 = CIP Cleaning is no longer possible
due to GMP Rules
- 1:1 Substitution on-site and in restricted time-
slots of 14days

A potential Solution was proposed,
accepted and ordered in March
2022

- extremely exposed dished
bottom in **ALLOY 59**
- all vertical inside Walls
in **ALLOY 31/24**
- high-frequency **CIP Cleaning**
with a modified Passivation
Procedure

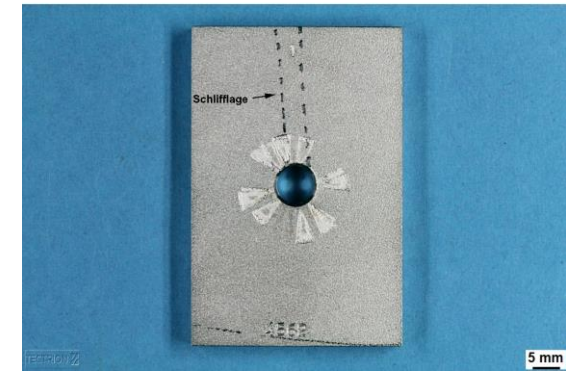
ALLOY 31

TEC Lab (Equivalence Comparison to Damage Case)
 Test - > 30days / pH 5.6 to 3.4 / T > 103°C sub boiling
