FOOD PRODUCER

HT-VESSEL IN 1.4404 FAILED
DUE TO HEAVY PITTING
CORROSION – FULL
SUBSTITUTION ON-SITE

Consulting for over 2 years resulted in a reliable Solution & Materials order for this revamping Project

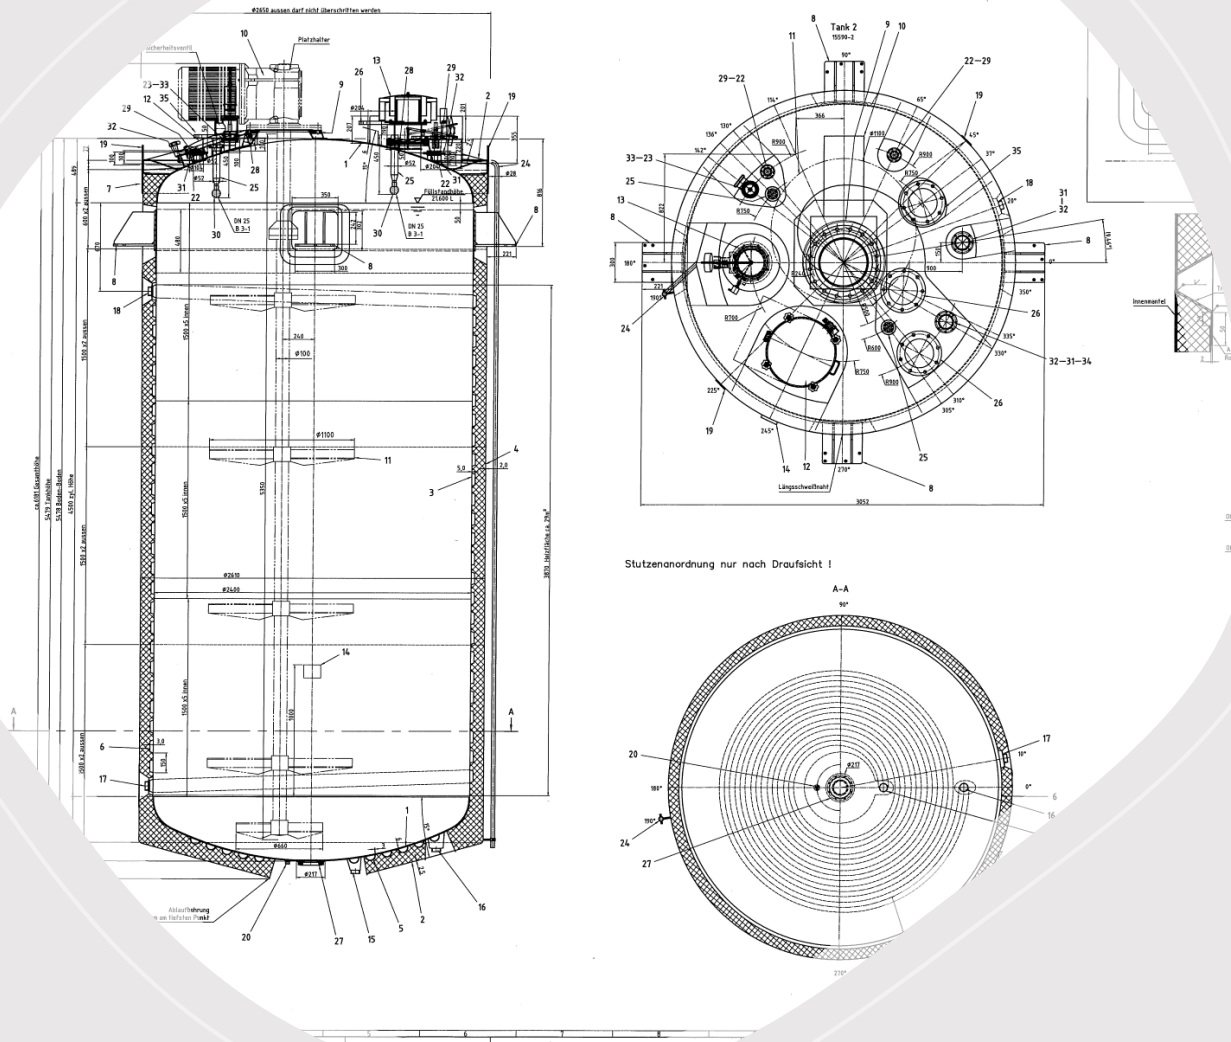
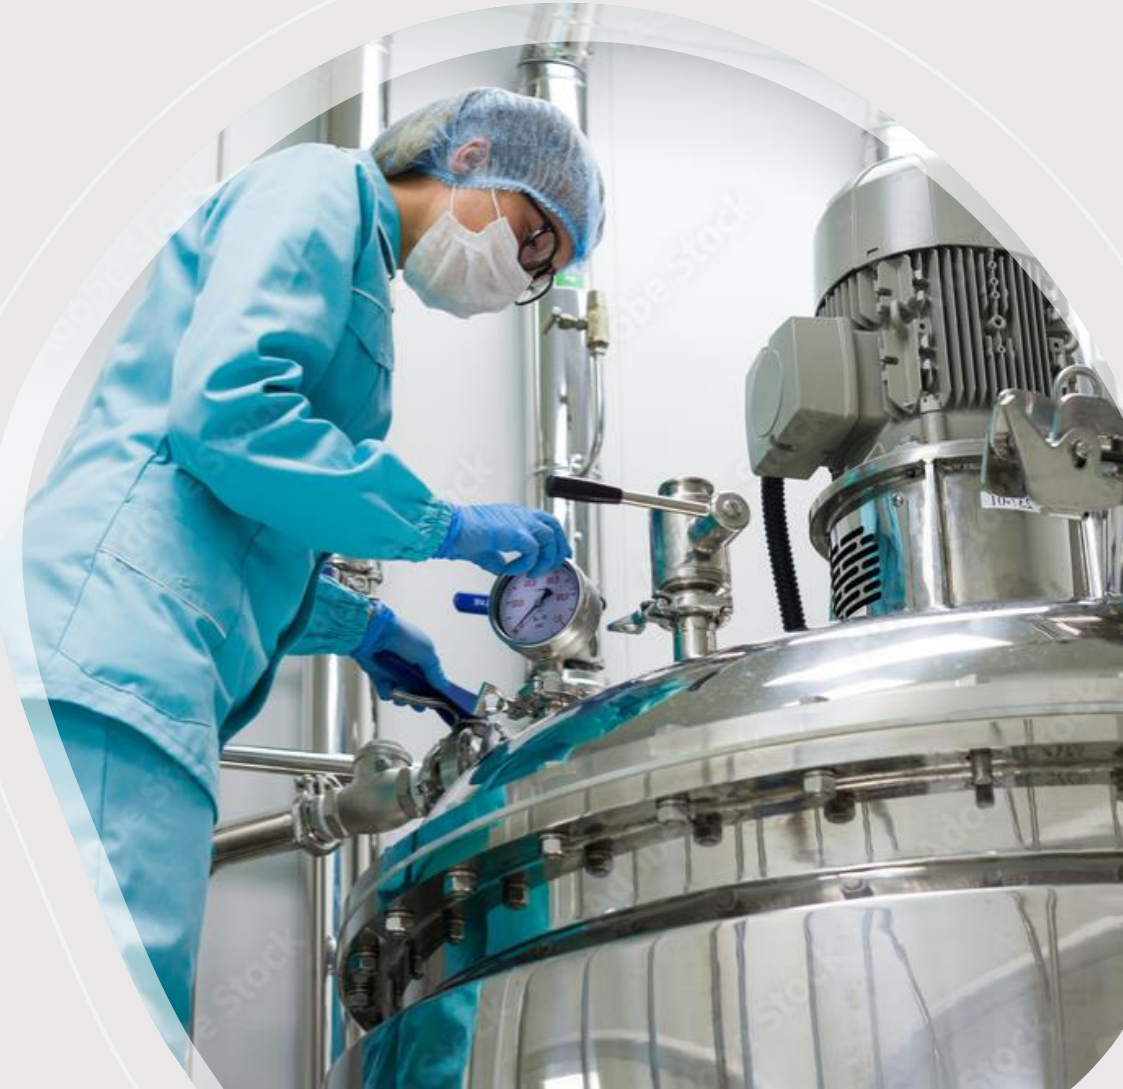
HT VESSEL 316L (1.4404) Inside Surfaces, including Mixer are affected by Pitting Corrosion

- Cooking Vessel for Food Mixtures Processing
H= 7m D=2.5m s=5mm Wall // Vol =24m³
- Temperature Regimes T = 85°C – 145°C /
pH -Regimes 5 down to 3.5 !
- 1st Vessel in Steel Enamel Coating and Mixer in
rubber-lined Construction (2010-2015)
- 2nd Vessel in 316L (1.4404) operated
from 2016-2020
- Heavy Pitting & Crevice Corrosion after
3 years operation only
- Dished Boiler Head close to leakage (!)
- Problem 1 = Vessel Stability / potential Interruption
of Production
- Problem 2 = Food contamination (!)
- Problem 3 = CIP Cleaning is no longer possible
due to GMP Rules
- 1:1 Substitution on-site and in restricted time-
slots of 14days

- (1) Vessel in Operation: No cut-out Sections for damage Investigations available
- (2) Customers Assumptions: The problem can/must be solved without Lab-Tests or Field Tests, although time was sufficient – more than 2 Years
- (3) Desperate Need to find Equivalence Cases through DataMining & Publication Research (TEC LAB Report- 1 Table & Pictures...)
- (4) 1st Orientation according to Pitting & Crevice Design Criteria
- (5) Change the frame Conditions to avoid Crevice Corrosion &
- (6) Change the Cleaning Intervals to higher frequent Cycles and apply Passivation Agents to recover protected Surfaces

A potential Solution was proposed,
accepted and ordered in March
2022

- extremely exposed dished
bottom in **ALLOY 59**
- all vertical inside Walls
in **ALLOY 31/24**
- high-frequency **CIP Cleaning**
with a modified Passivation
Procedure

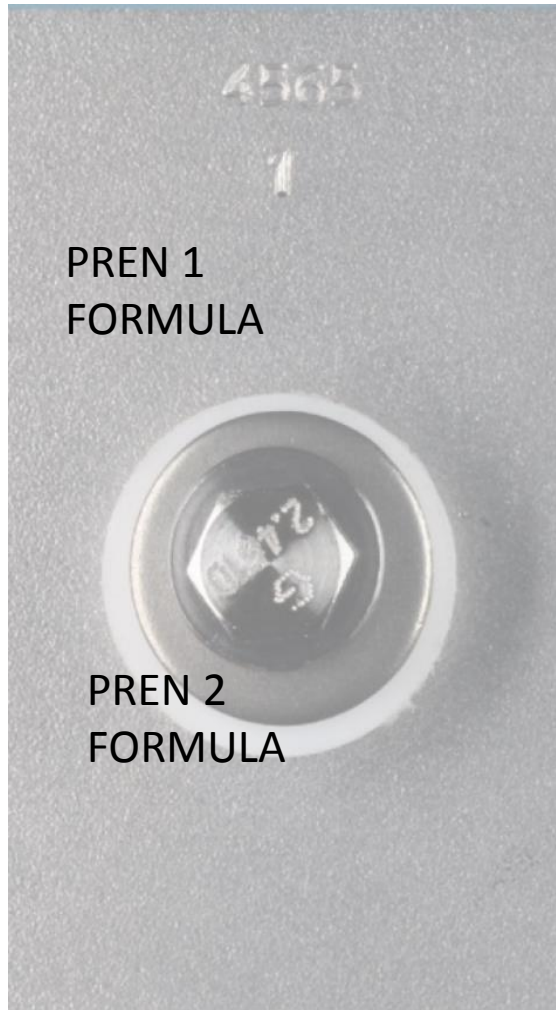
Design for Corrosion Resistance; Pitting Resistance Equivalent Number (PREN)

PREN 1 & 2 permit a first orientation and ranking against Pitting Corrosion and Crevice Corrosion

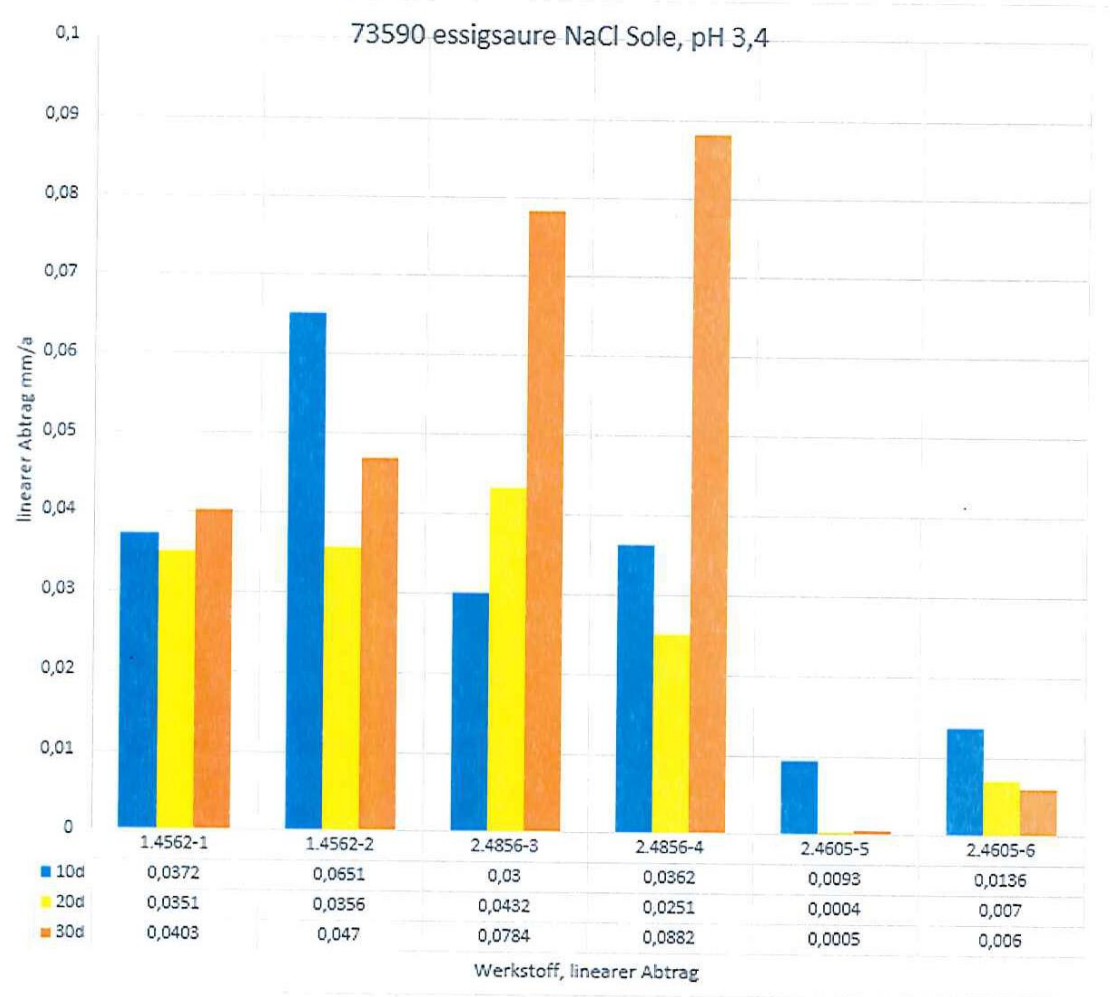
TEC Lab (Equivalence Comparison to Damage Case)
 Test - > 30days / pH 5.6 to 3.4 / T > 103°C sub boiling
